## CASE STUDY **LEISURE MANAGEMENT**

# INFILTRATION ANALYSIS FOR AN EXPLANDING HOLIDAY PARK

A leisure industry business that owns a large caravan & holiday park in Wales that attracts more than 200,000 visitors and employs hundreds of people, contracted Detectronic to implement two flow surveys at the site.

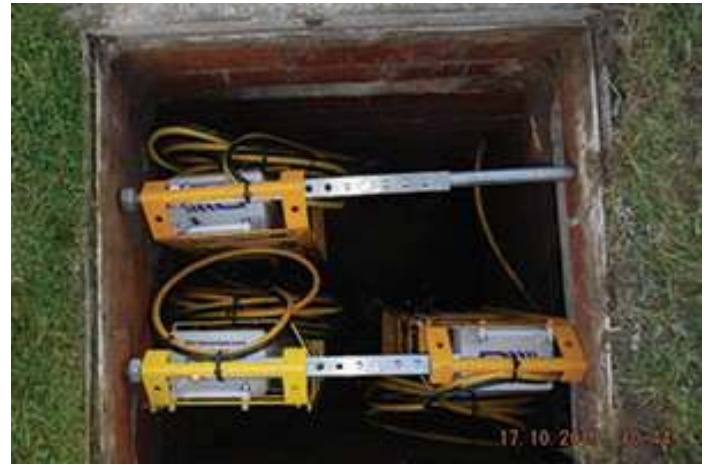
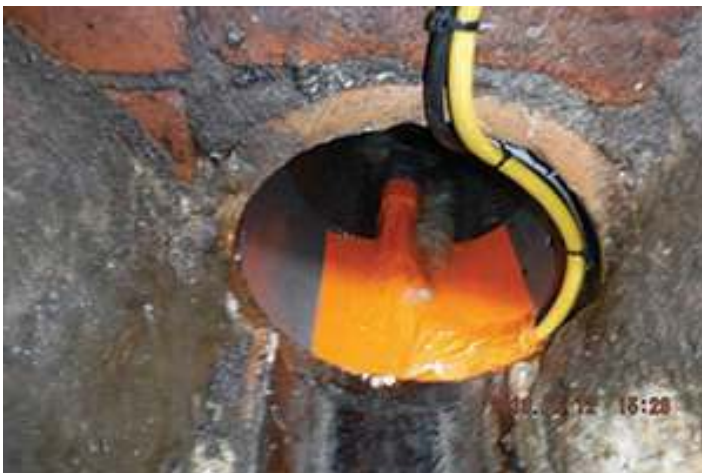
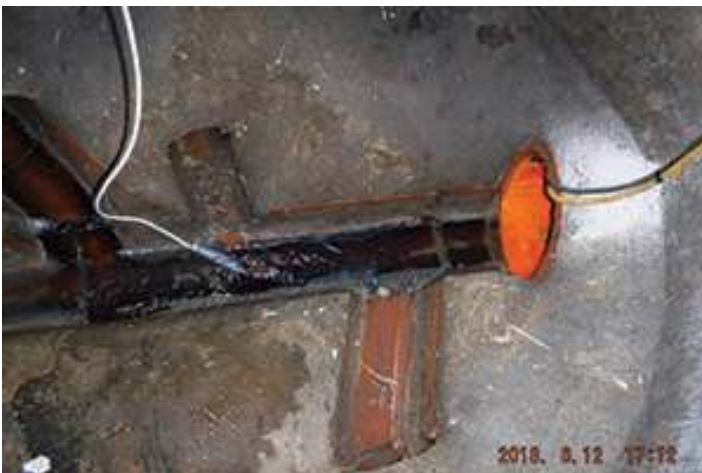
“The purpose of this initial survey was to deliver inflow and infiltration analysis and our team installed MSFM flow monitors and two rain-gauges at nine strategic locations across the site to gather data.

“Each of the monitors gave us very specific data relating to depth, velocity and rainfall impact at each location which, in turn, provided diurnal patterns and enabled our data centre analysts to provide a full report highlighting a number of issues that might affect the development.”

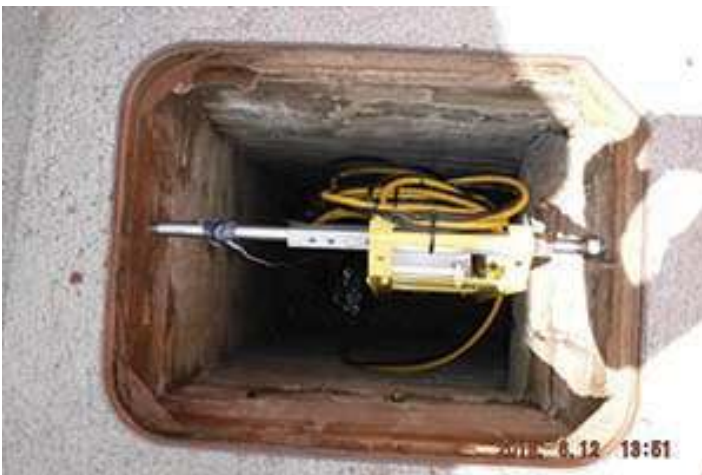
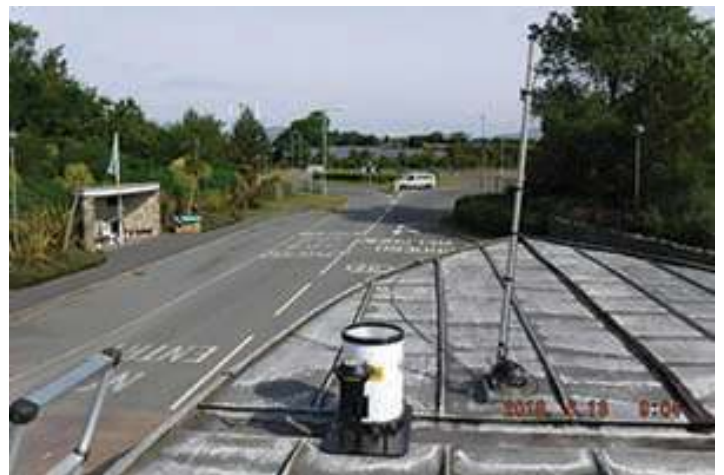
Continues Oliver: “In order to assess the efficacy and success of the consequent remediation work, we were asked to implement a second inflow and infiltration analysis survey commencing in June 2018 and running for an eight-week period. For this survey we recommended and installed ten MSFM flow monitors, two rain-gauges and a pump run monitor at different locations within the holiday park.
